Programmed repairs

Complaint:

Uneven tire wear patterns on front axle

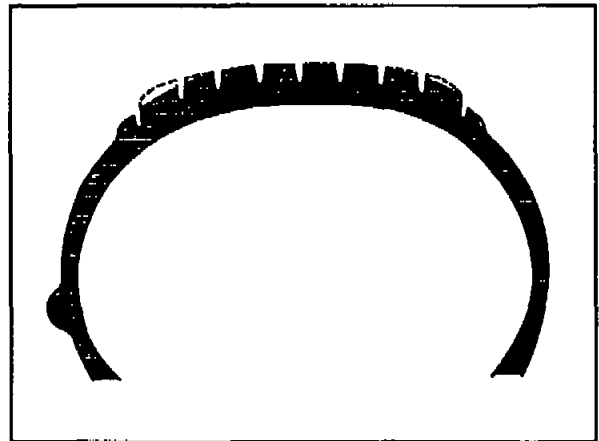
P40-0130-13

On front wheels a somewhat increased wear of the tire shoulders compared to the center of the contact patch is quite normal. The wear of the shoulder pointing towards the middle of the road can be more pronounced (e.g. in countries with righthand traffic, left wheel outboard, right wheel inboard).

Shoulder wear on front tires

Depending on service conditions, driving habits, tire make and tire type, an increased wear of approx. 2 mm for 10,000 km at the shoulder can be considered normal as compared to the center of the contact patch.

A. Correct wheel alignment on front axle:

- Adjust camber to lower tolerance limit
 - Adjust caster to upper tolerance limit
 - Check ball point position
- Toe-in, ready-to-drive (front of wheels pressed apart with 90 to 110 N). Set to specified value.

B. Note specified tire rotation intervals; according to experience between every 5,000 to 10,000 km of service life.

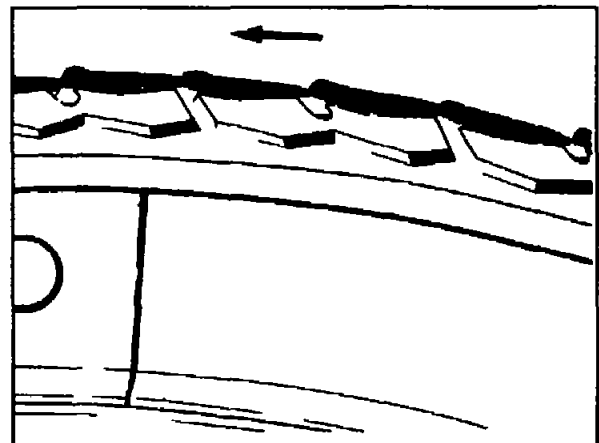
P40-0129-13

In addition, scrubbing at the shoulders can cause saw-tooth profiles, depending on tire tread patterns and service conditions.

Saw-tooth wear pattern at tire shoulder

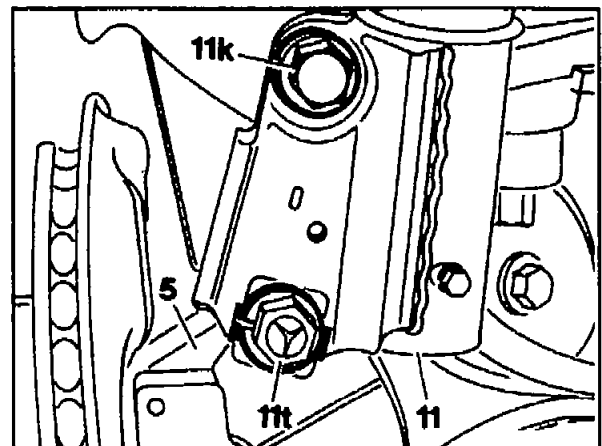
P33-2111-13

Tire/outboard shoulder wear at the front wheels.

Check wheel alignment at the front axle
Set or aim for the following guidance values

- Camber: - 0° 50'
- Caster: 10° 30'
- Track: - 0° 10' (pressed)

If the values cannot be achieved by turning the eccentric bolts, loosen damper strut mounting bolts (11k and 11t) and press the wheel in the direction of negative camber. Tighten mounting bolts.

Tightening torque 185 Nm.
